**PRELIMINARY DRAFT BIG TUJUNGA WASH
SEMI-ANNUAL MITIGATION BANK REPORT
JANUARY – JUNE 2004**

**LOS ANGELES COUNTY DEPARTMENT OF PUBLIC WORKS
900 S. Fremont Avenue
Alhambra, California 91803-1331
(626) 455-6138**

**CHAMBERS GROUP, INC.
17671 Cowan Avenue, Suite 100
Irvine, California 92614
(949) 261-5414**

August 2004

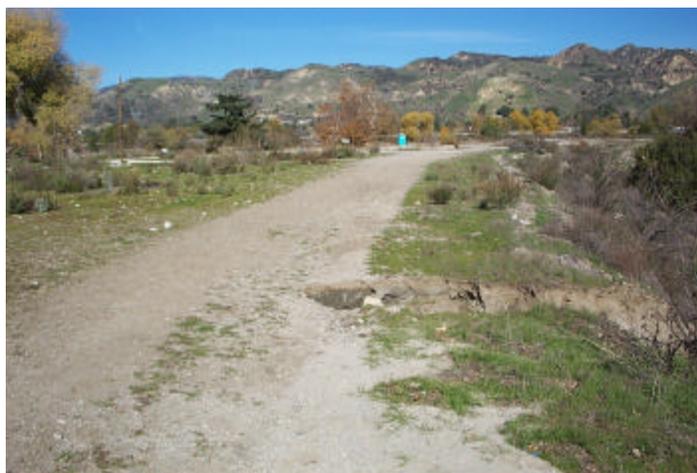
Figure 8-2a
Erosion gully near the upland area before repair work.

The erosion gully that was present in the upland habitat area was repaired by Flood Maintenance during this reporting period. The runoff is now being diverted via a pipe flume. Figures 8-2a and 8-2b show the upland erosion area before and after installation of the pipe flume. The railroad ties that were used to block off the erosion gully below the Cottonwood bluff is still intact and has been successful in preventing foot and equestrian traffic through the gully.
